**US Army Corps
of Engineers**

CERL Technical Report 99/72
August 1999

Piezoelectric Patch Sensors for Structural Integrity Monitoring of Composite-Upgraded Masonry and Concrete Structures

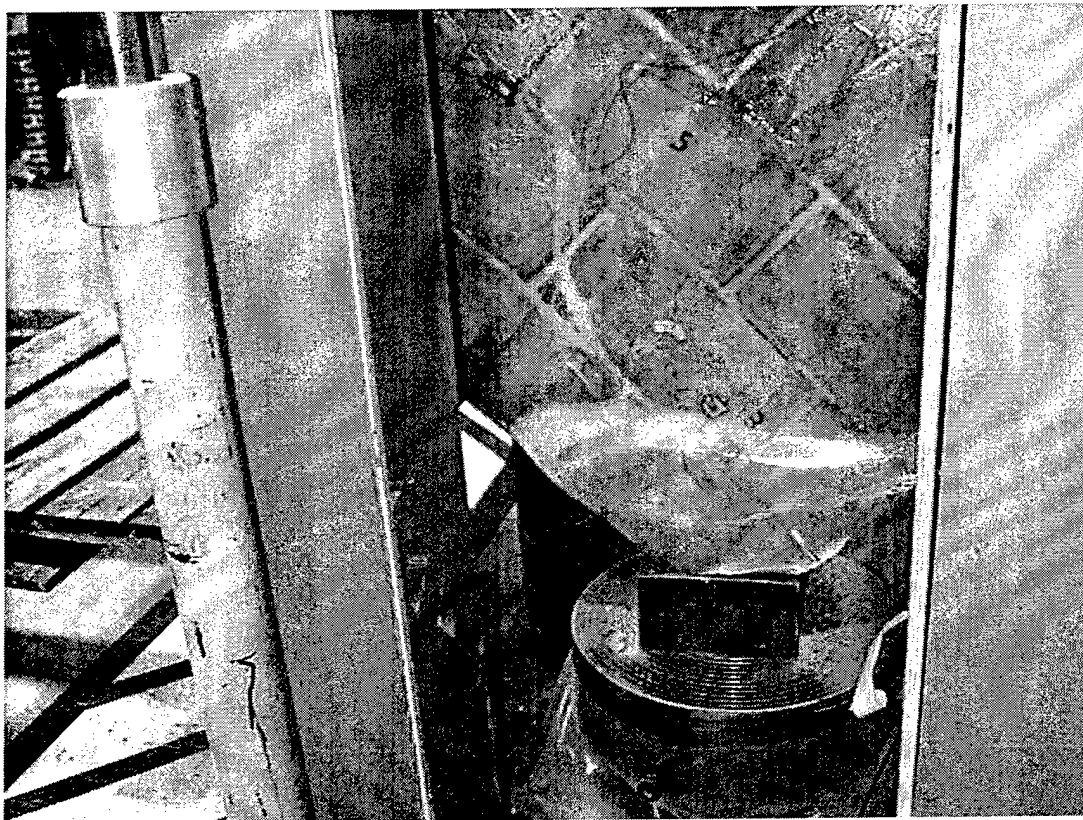
Figure 30. Wall 6 after failure. Note the large section of composite layer that has debonded near the bottom load shoe. The top to bottom failure in the wall can be seen as a lighter gray zigzag on the left of the picture.

The wall broke at 46,000 lb but continued to hold the load. A stairstep crack appeared in the wall (see inset diagram in Figure 27). The break occurred while measuring PE sensor 4, so the data for PE sensors 4 and 5 are missing from the chart. The wall continued to hold the load until it failed at 56,000 lb. When the wall broke, the damage metrics for all PE sensors jumped. The composite material held the wall together, however, enabling the wall to continue holding the load. When the wall finally failed completely, the composite layer sheared off the bottom blocks and the lower blocks collapsed (see Figure 30).
